ผลกระทบของภัยพิบัติแผ่นดินไหวจากรอยเลื่อนสะกายต่ออาคารสูงในกรุงเทพฯ และการเตรียมพร้อมรับมือกับแผ่นดินไหวในอนาคต

ศ.ดร. เป็นหนึ่ง วานิชชัย

ภาควิชาวิศวกรรมโครงสร้าง
สถาบันเทคโนโลยีแห่งเอเชีย (AIT)

Summary of Damages

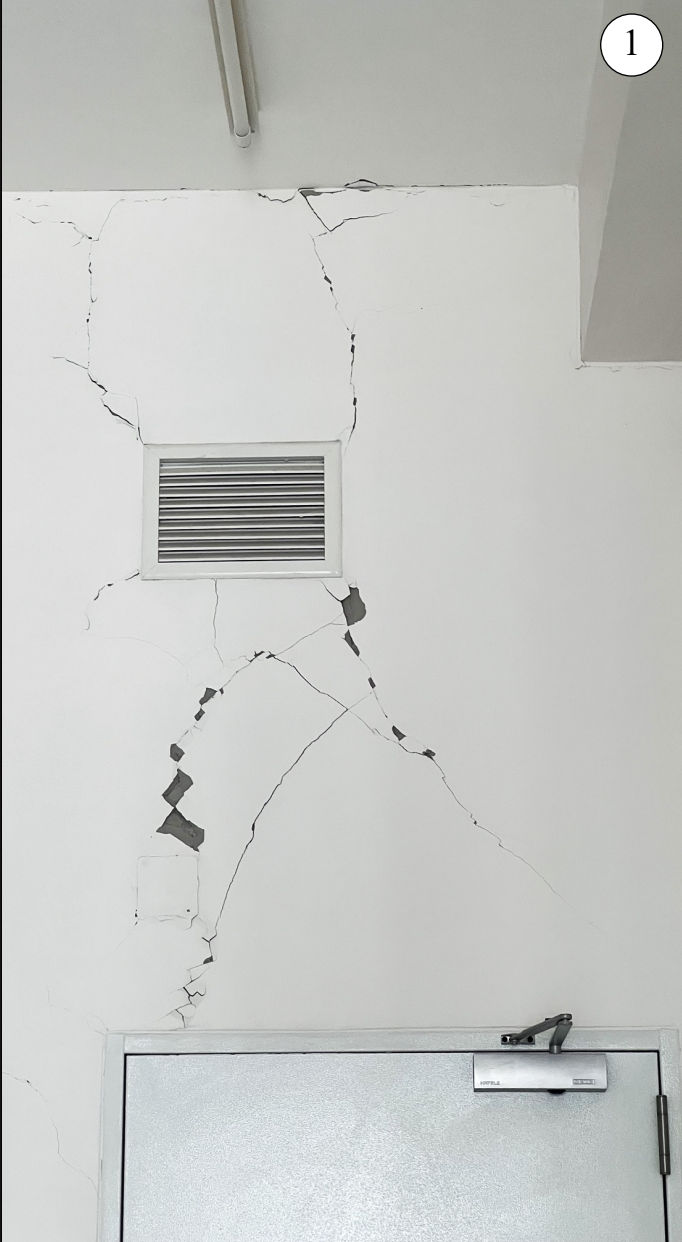
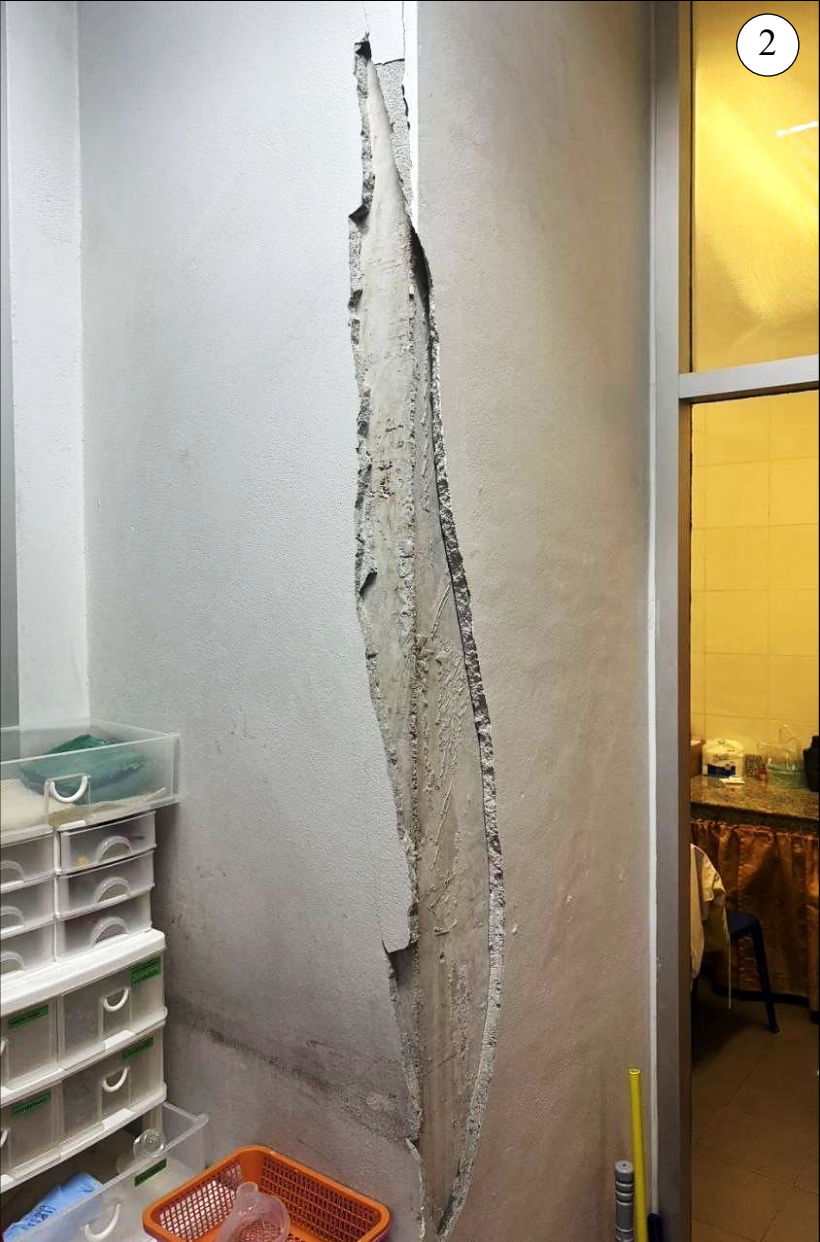
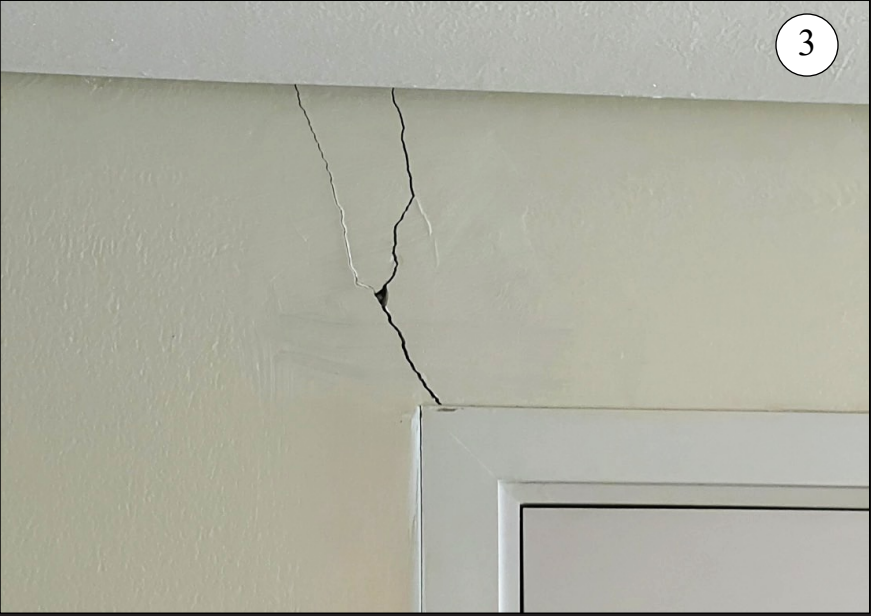
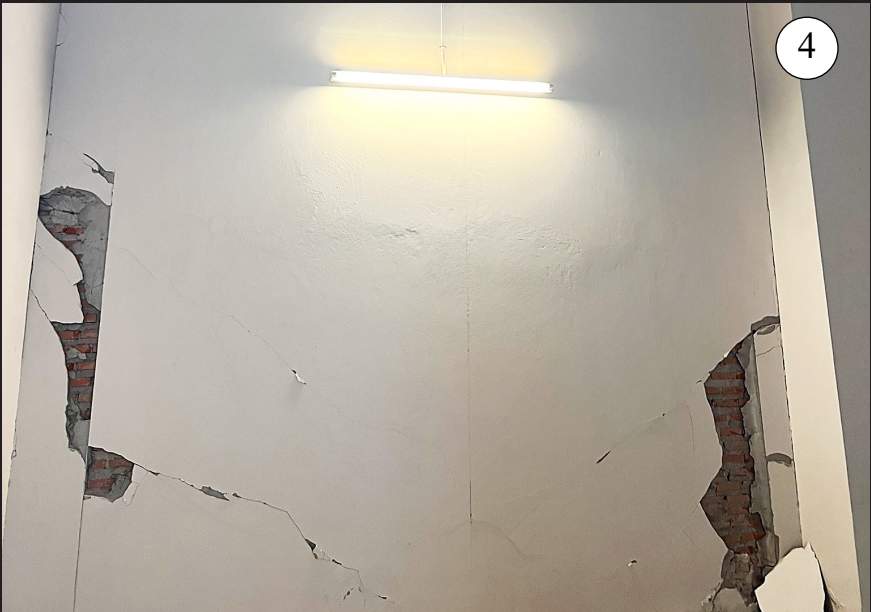
Slight to Moderate Damage to Non-Structural Masonry Walls

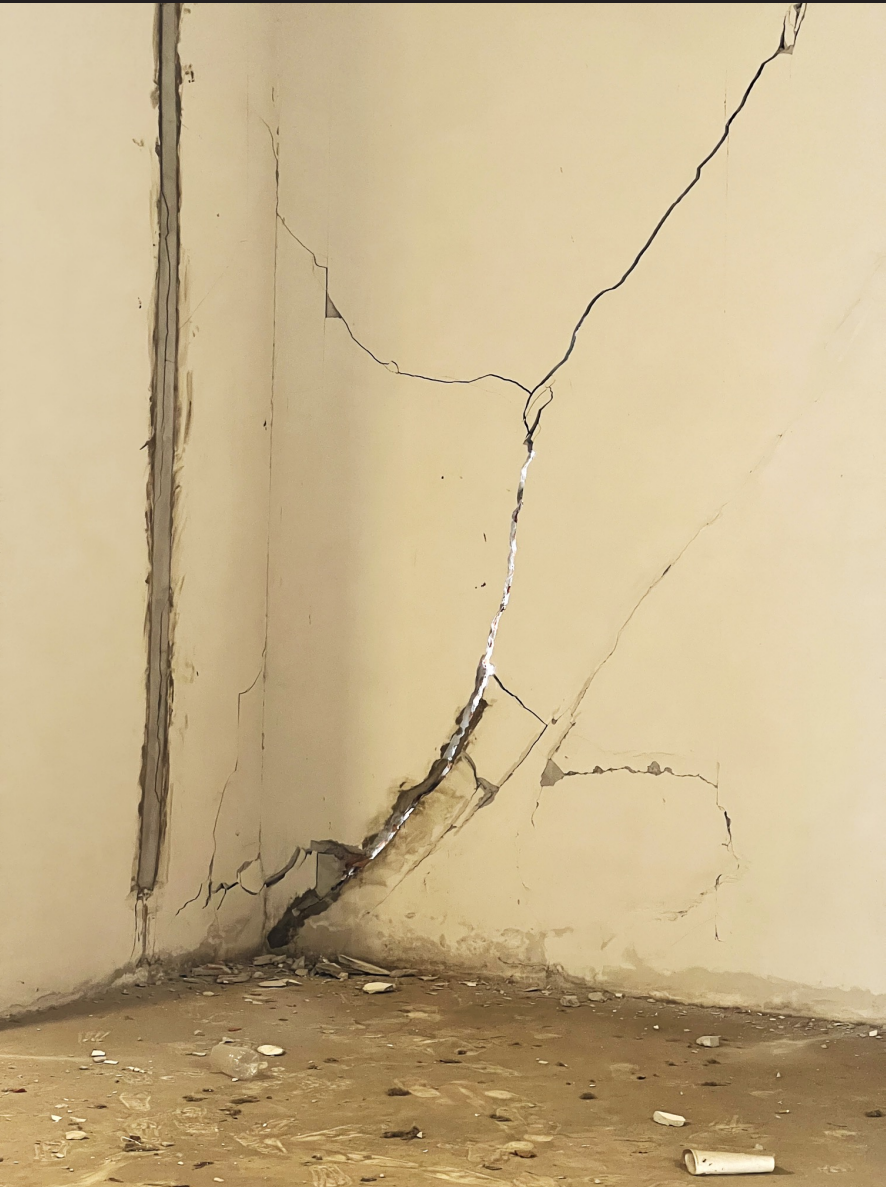
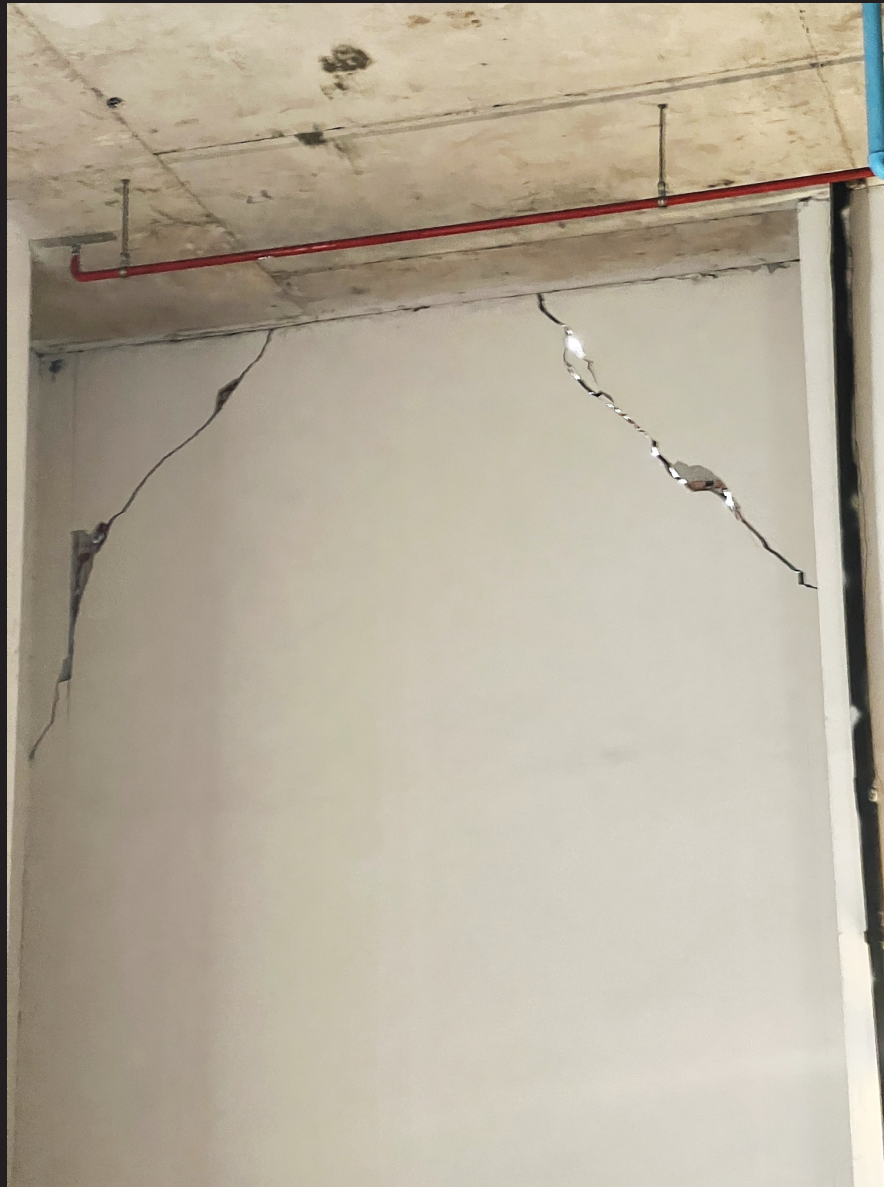
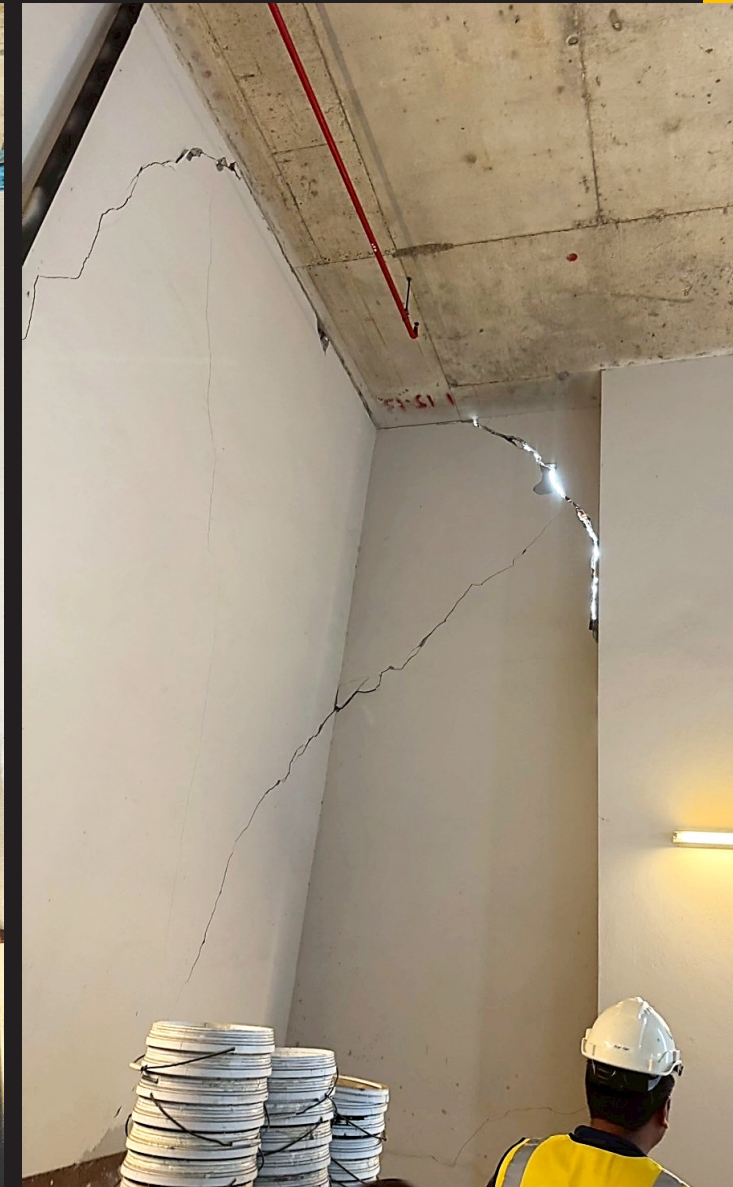
Severe Damage to Non-Structural Masonry Walls-ผนังอิฐก่อร้าวทะลุสองฝั่ง

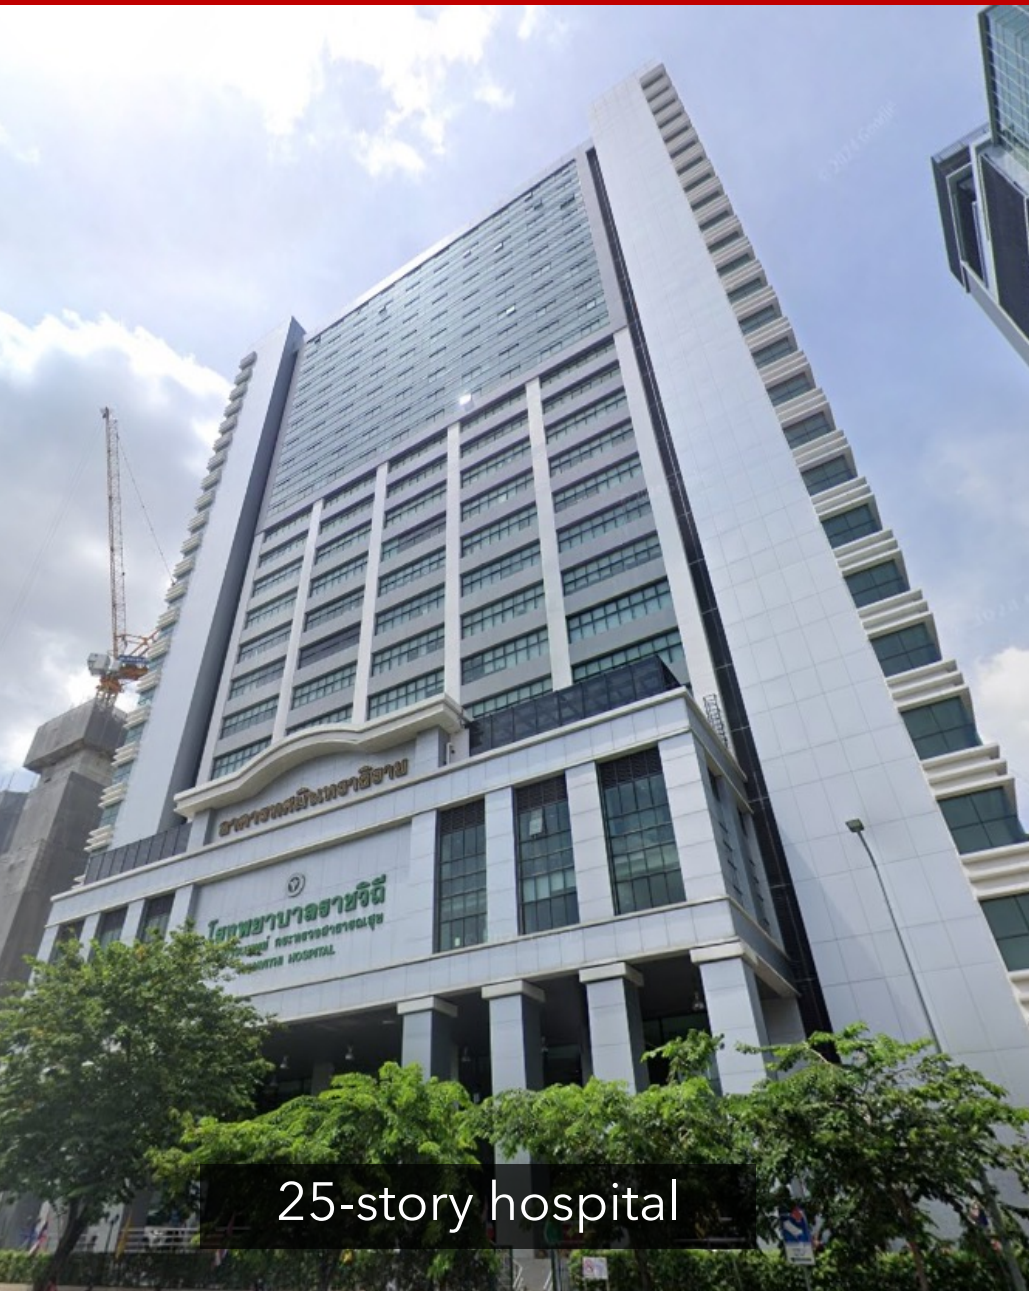
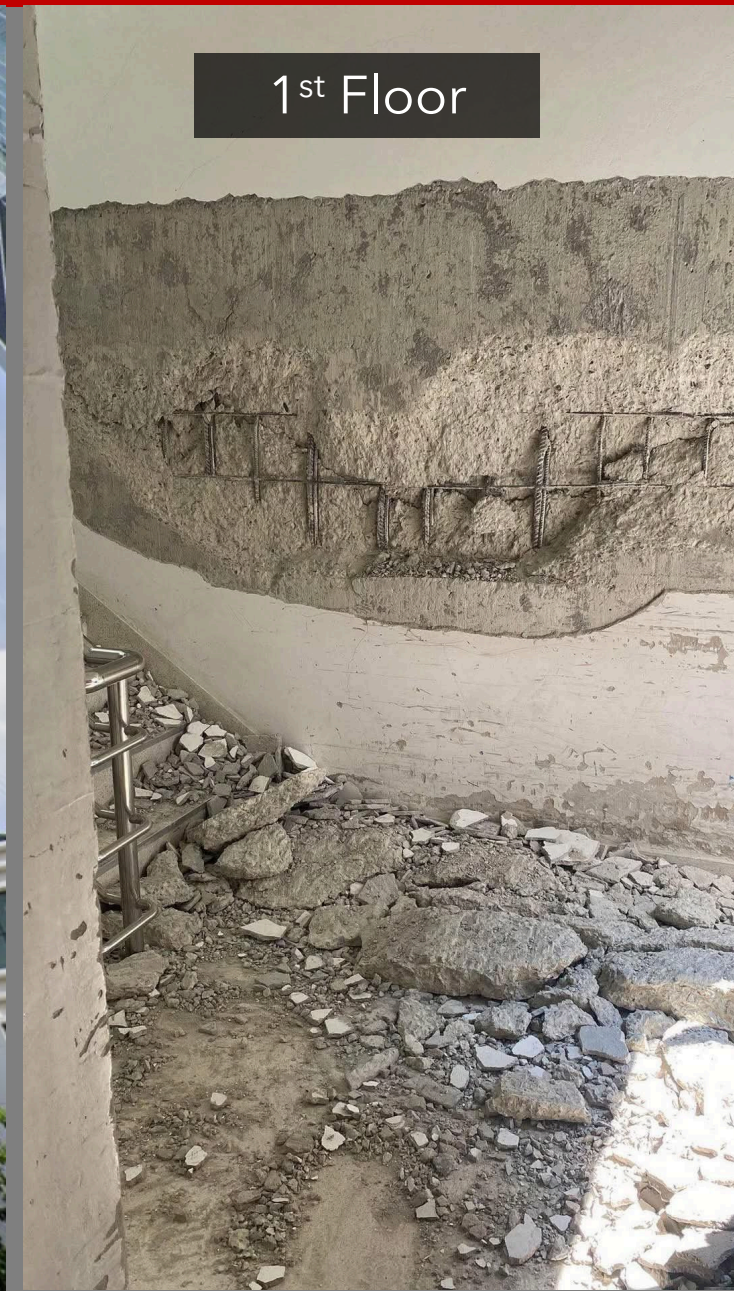
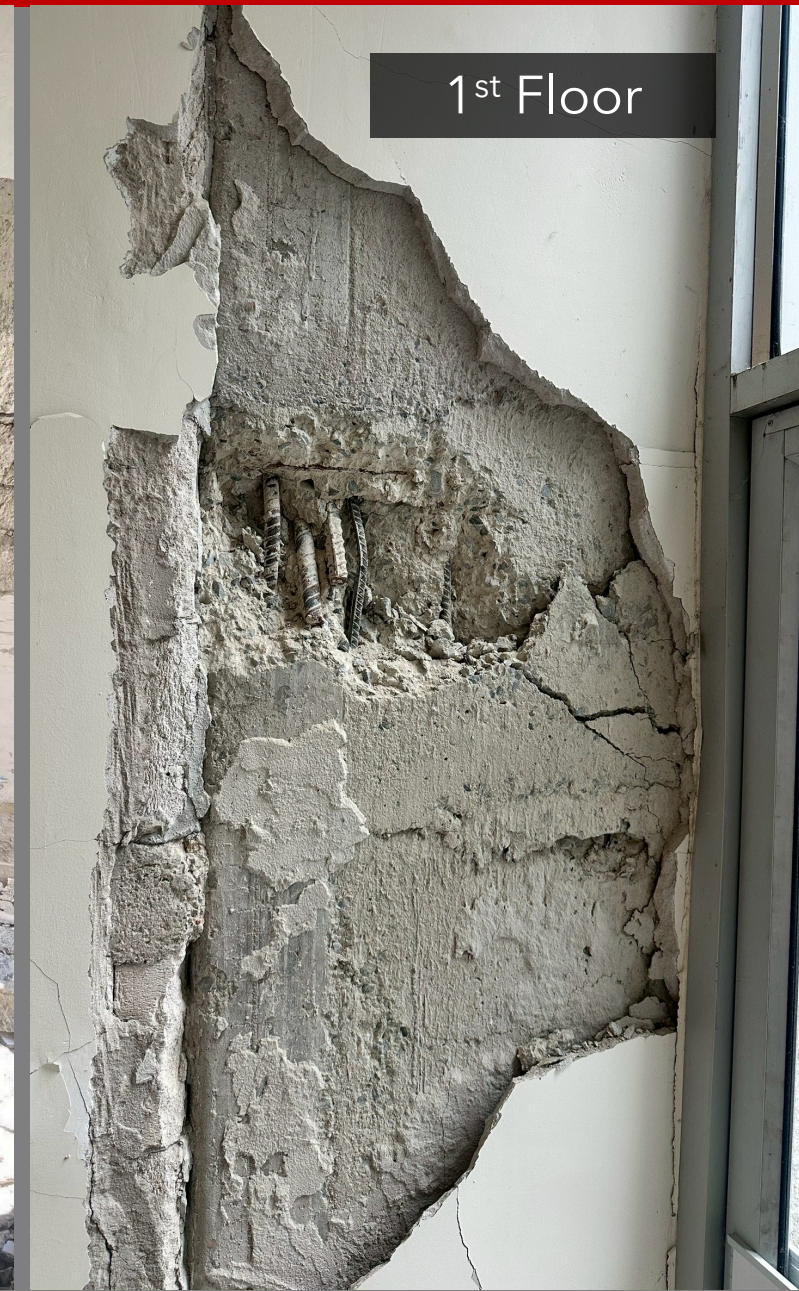
Significant Structural Damage (25-story, Rajavithi Hospital)

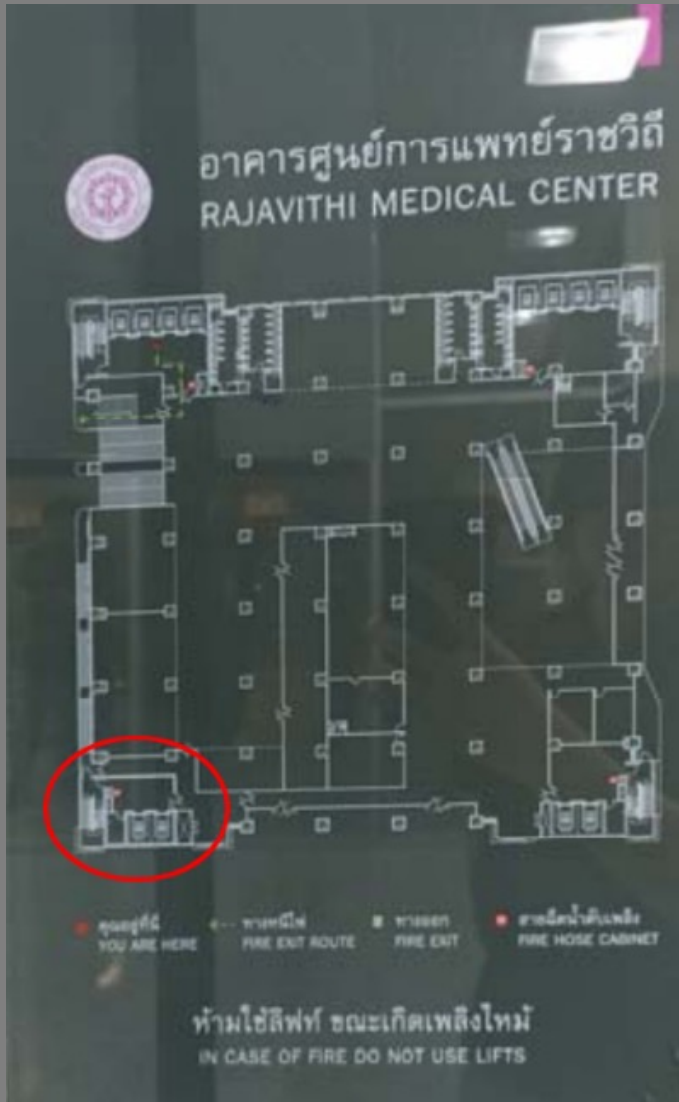
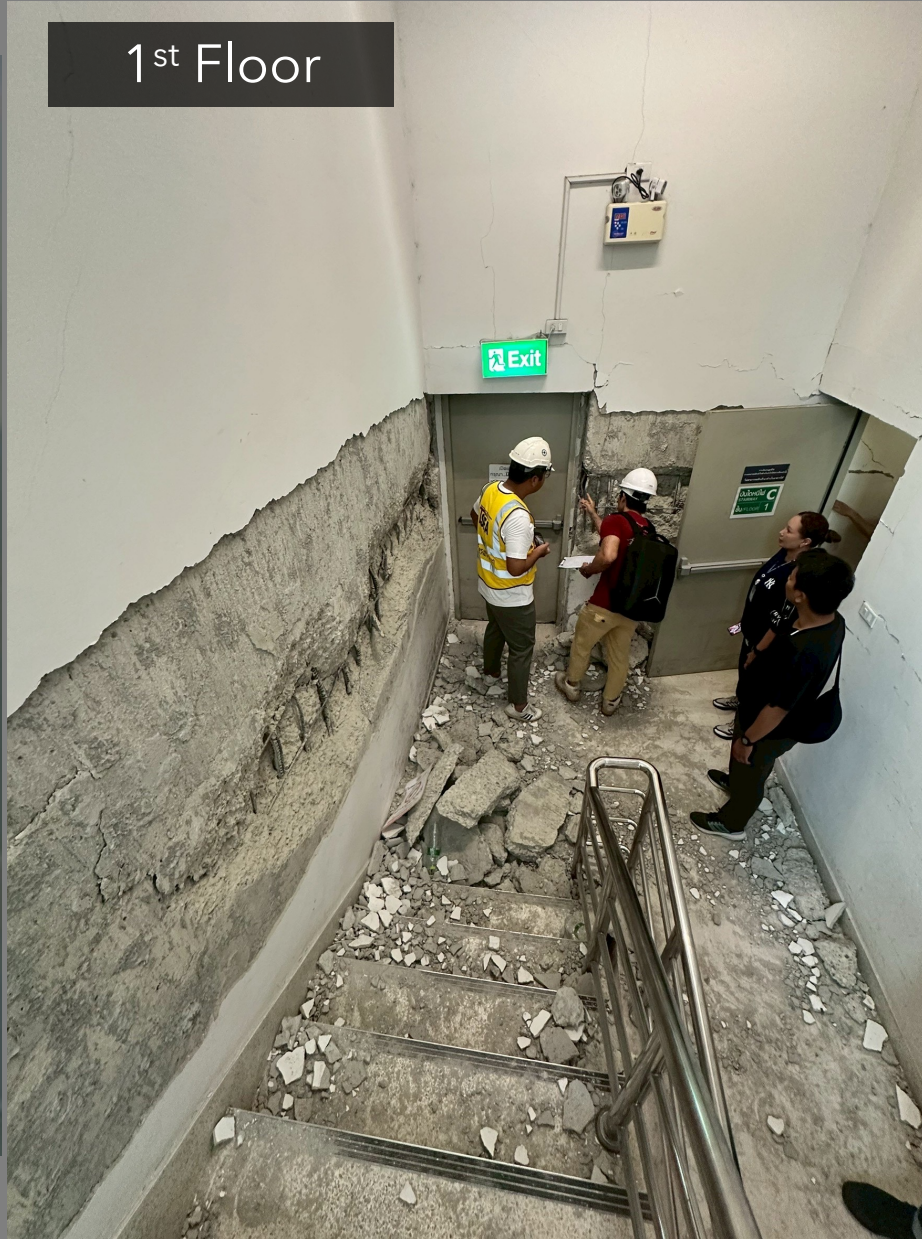
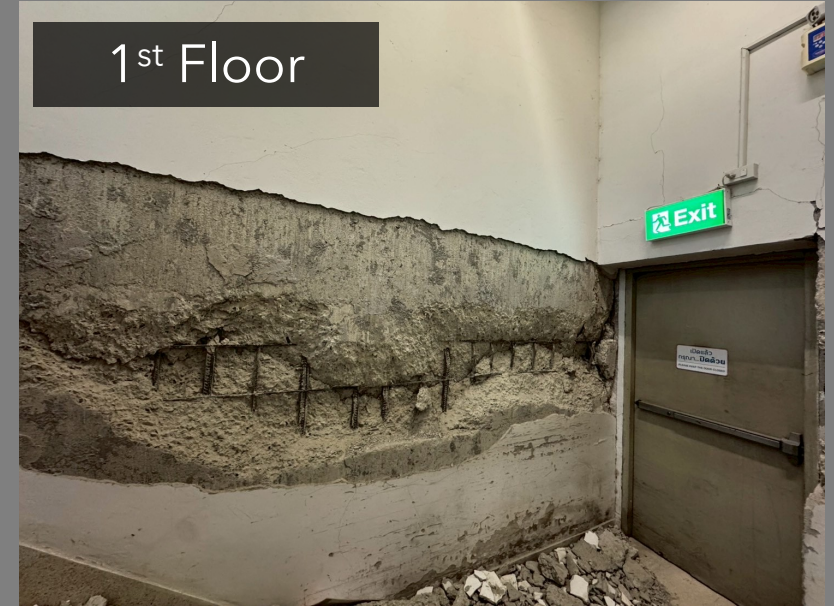
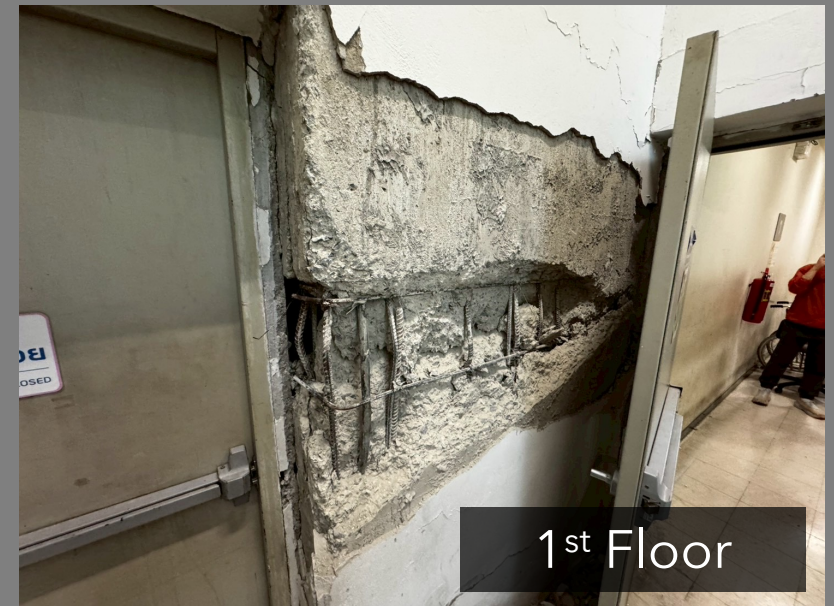
Significant Structural Damage (25-story, Rajavithi Hospital)

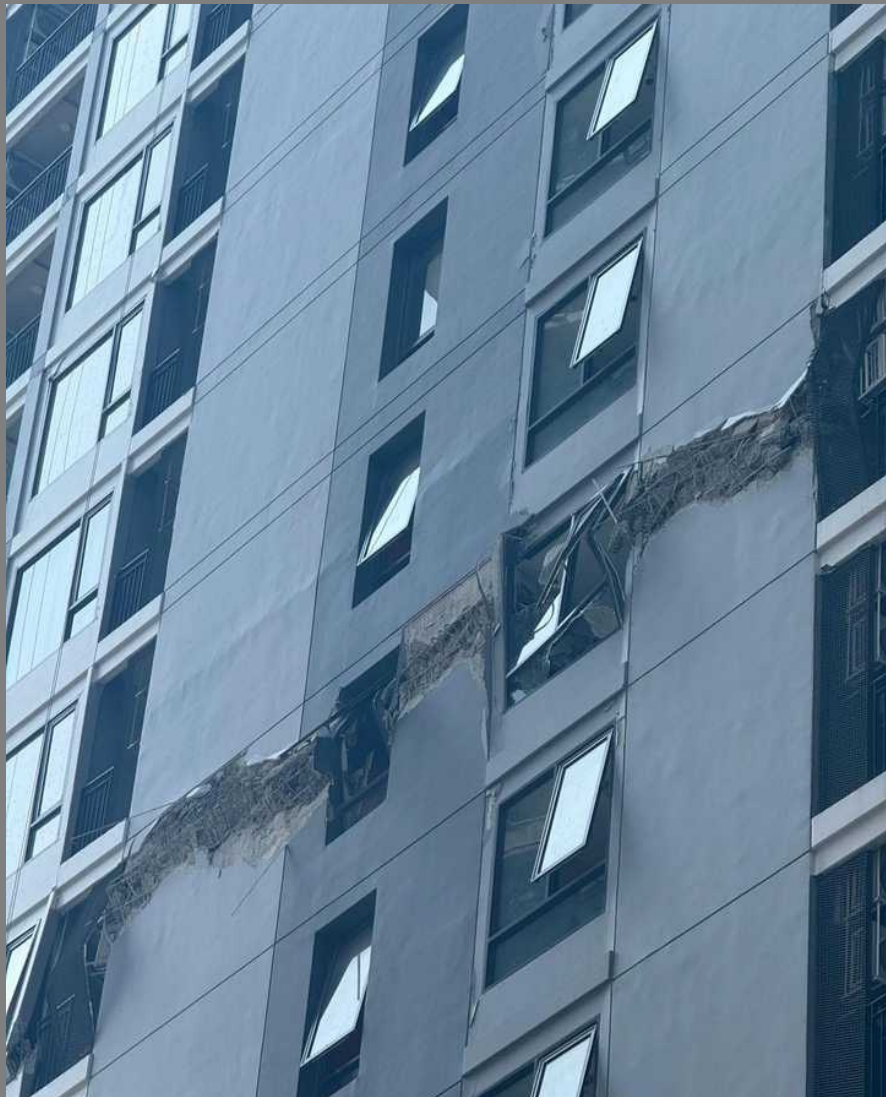
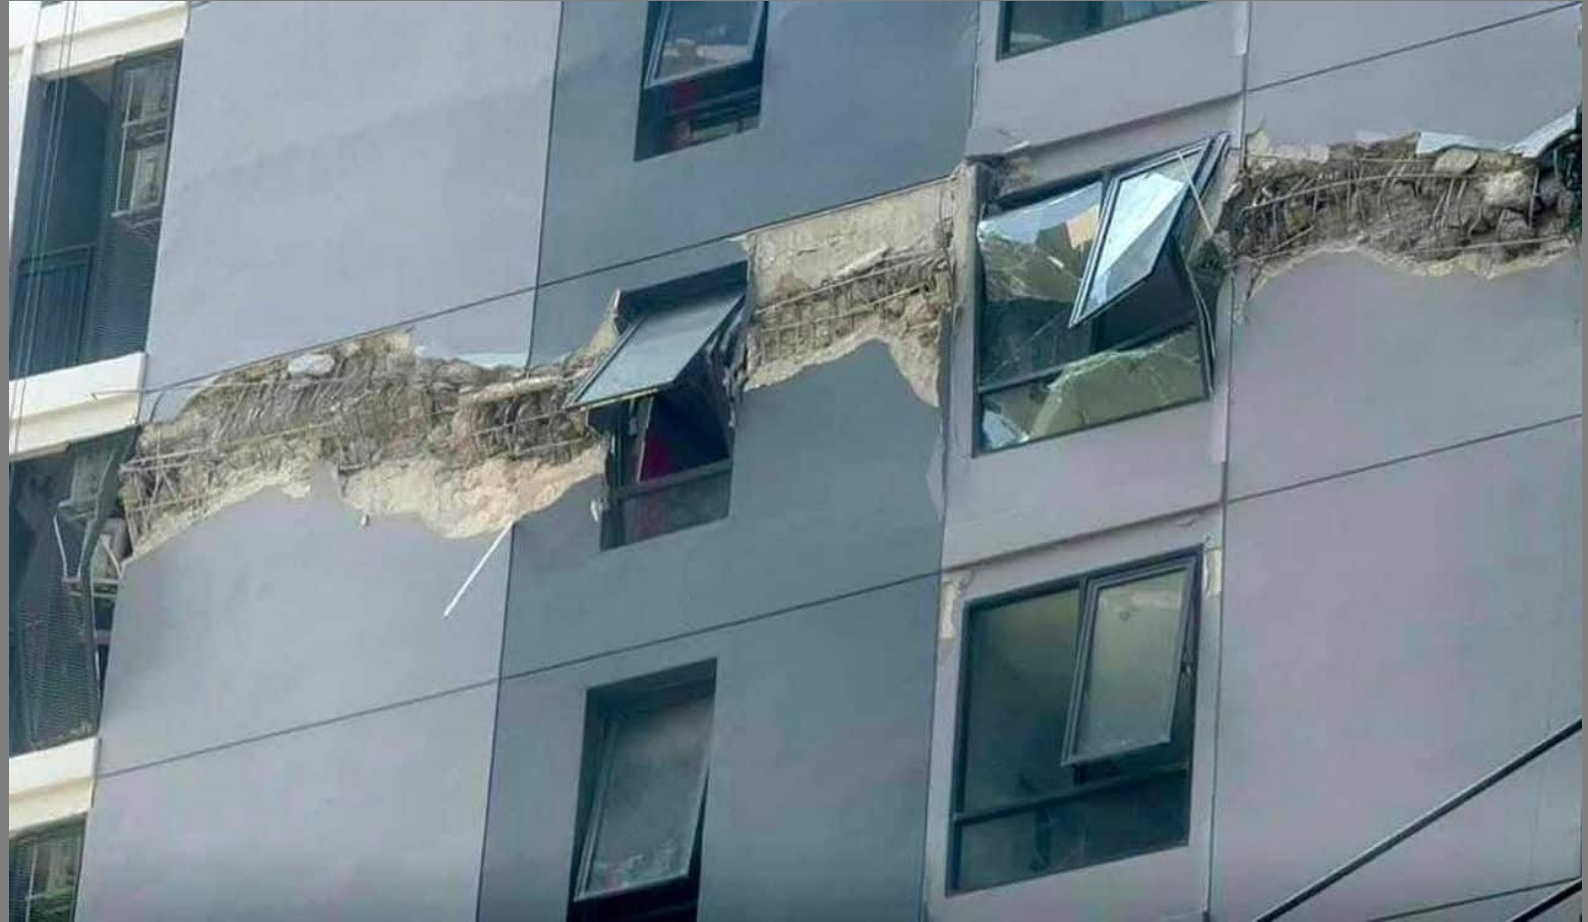
Significant Structural Damage (Building in Bangkok)
